Manhole Inspection Summary

Manhole # S29QQ_017MH

Inspection ☐ Is Incomplete Rating: **3) Fair**

Location Address: **2701 FALLS RD**

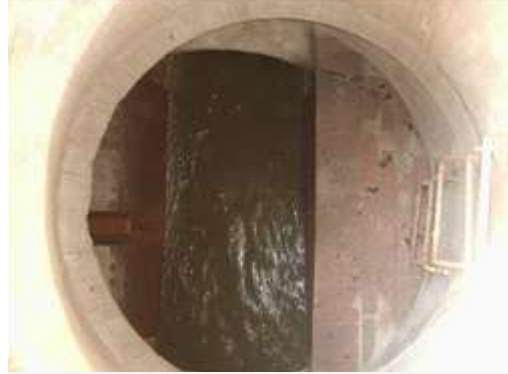
Top View

Bench debris.

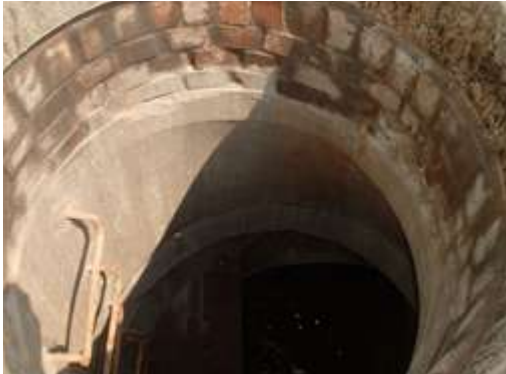
Defect

Frame leaks. Adjustment deterioration and infiltration. Corbel infiltration - other side.

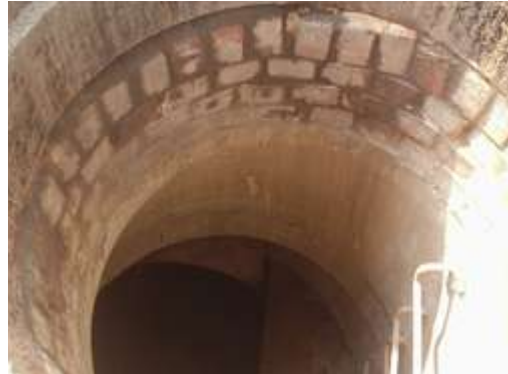
Defect

Frame leaks. Adjustment deterioration and infiltration. Corbel infiltration.

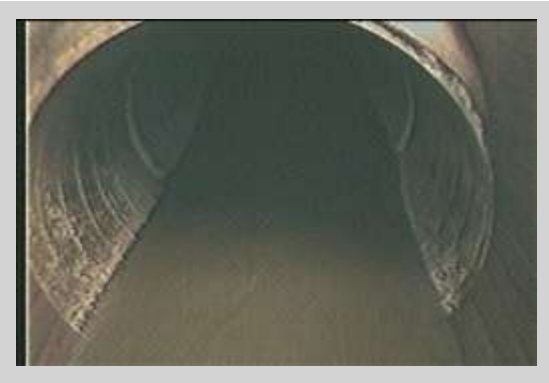
36 in. Circular Gravity Sewer Pipe Out @ 12 O'Clock

Pipe Material: **Unknown** ☒ Pipe Lined

Invert Depth: **11.60** (ft.) Flow Characteristics: **Fast**

Deposits: ☒ None ☐ Mud ☐ Sludge ☐ Debris ☐ Grease

Infiltration: **None** Pipe Seal Cond: **Unknown**

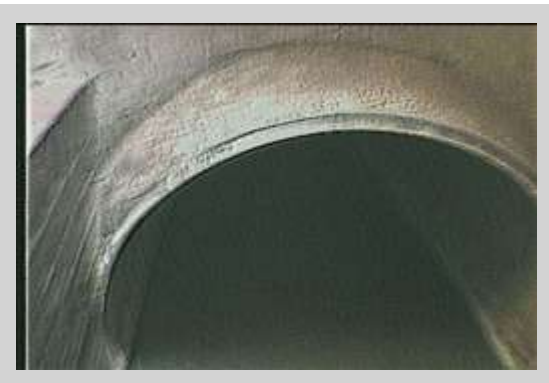
36 in. Circular Gravity Sewer Pipe In @ 6 O'Clock

Pipe Material: **Unknown** ☒ Pipe Lined

Invert Depth: **11.50** (ft.) Flow Characteristics: **Fast**

Deposits: ☒ None ☐ Mud ☐ Sludge ☐ Debris ☐ Grease

Infiltration: **None** Pipe Seal Cond: **Unknown**

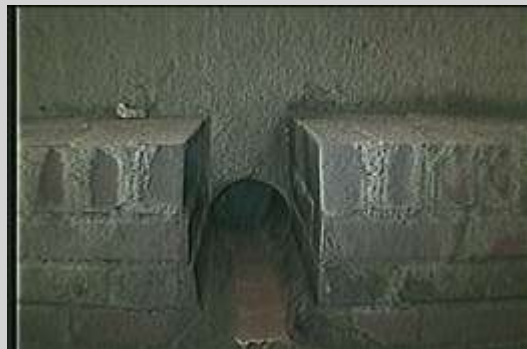
Pipe In @ 9 O'Clock

Pipe Material: **Unknown**

Invert Depth: **9.40** (ft.) Flow Characteristics: **Slow**

Deposits: ☒ None ☐ Mud ☐ Sludge ☐ Debris ☐ Grease

Infiltration: **None**
